TECHNICAL REPORT ARCCB-TR-92004

155-MM M284 GUN TUBE FAILURE

SANDRA O. ROY
JOHN ATCHINSON

FEBRUARY 1992

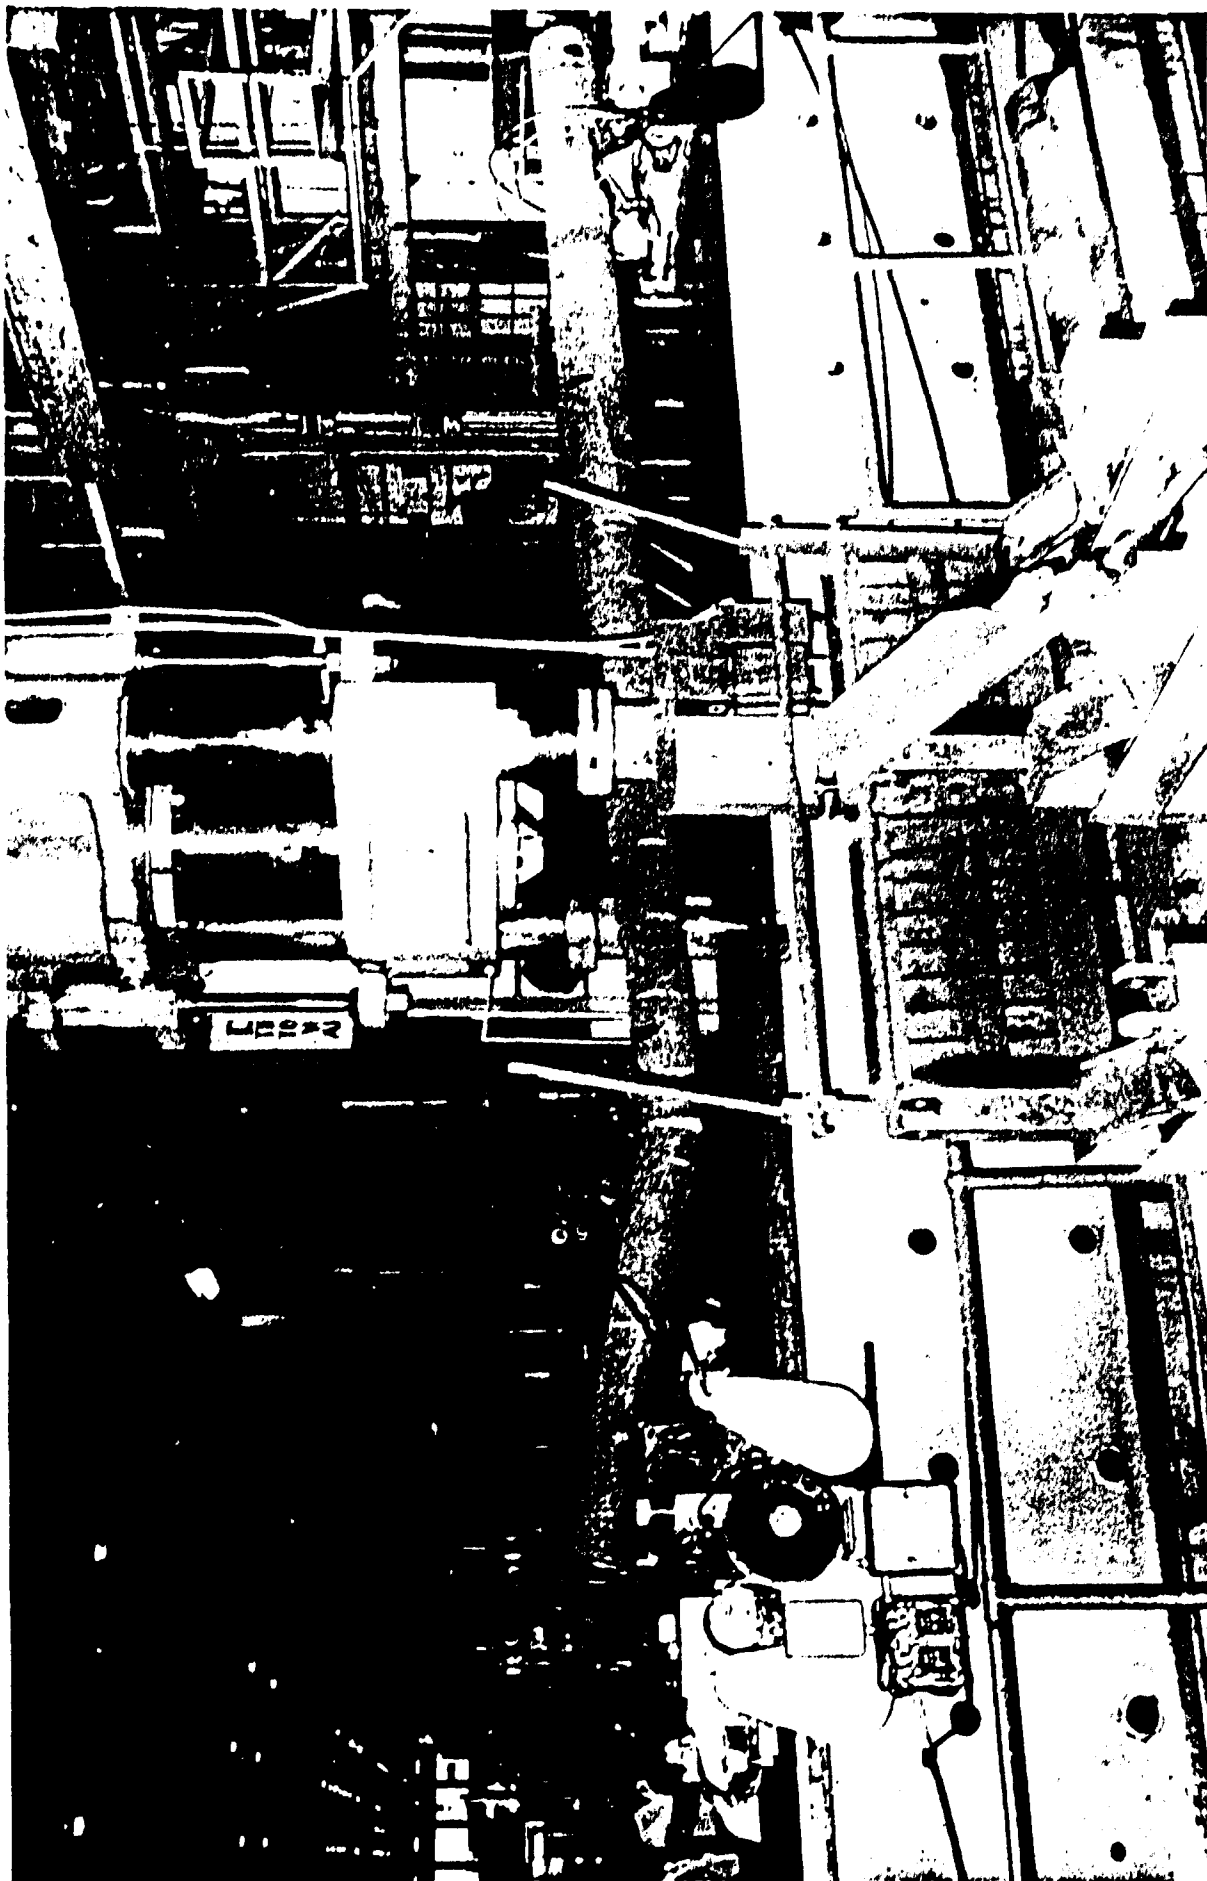
During a routine straightening operation, a 155-mm M284 gun tube forging (serial no. 0242) fractured while being pressed, as shown in Figures 1 and 2. According to the press operator, failure occurred when the loading conditions reached 260 tons. Typically, a gun tube may be subjected to loads up to 400 tons. At the request of the Chief, Manufacturing Division of the Watervliet Arsenal, the Advanced Engineering Branch of Benet Laboratories conducted a failure analysis on the subject gun tube to determine the cause of failure.

Figure 1. Fractured gun tube forging (serial no. 0242) on the straightening press.

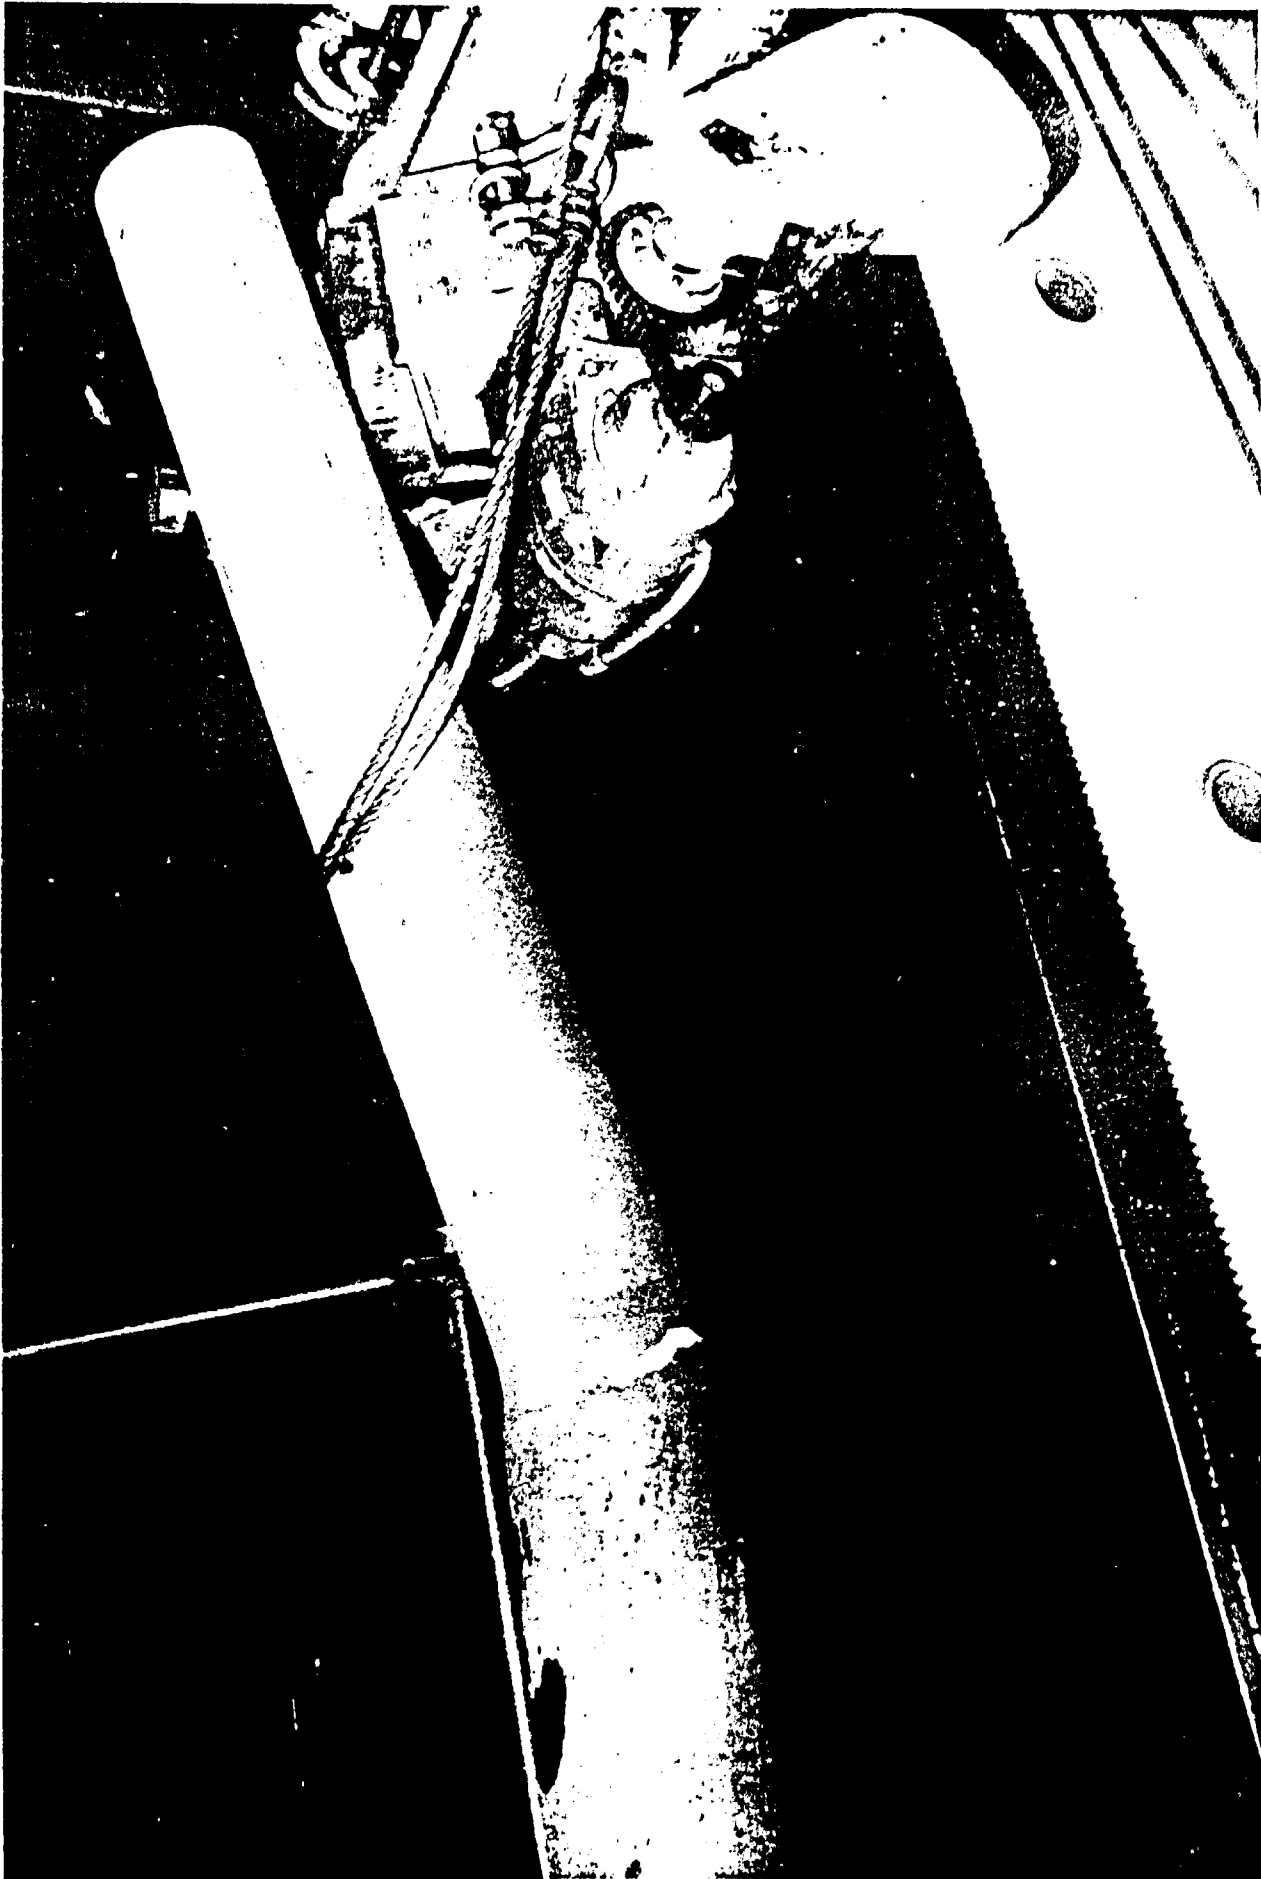
Figure 2. Close up of tire on straightening press.

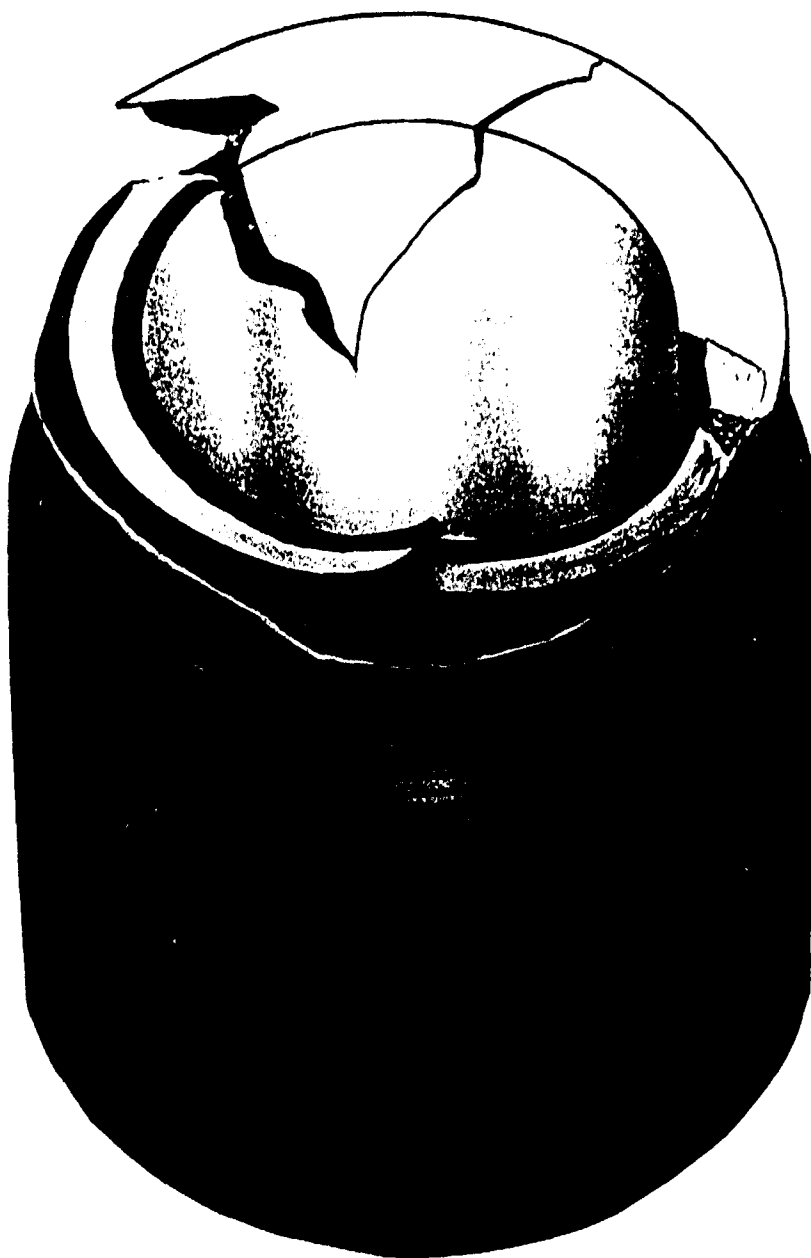
Upon receiving the failed gun tube forging, a thorough visual examination was conducted. Two segments of the failed tube were received from the Manufacturing Division: a segment approximately 15 inches long (closer to the breech end labeled M1) and a section approximately 11 inches long labeled M2 depicted in Figures 3 and 4, respectively. The failed region is located roughly 62 inches from the muzzle end.

Figure 3. Segment of gun tube with fracture located near breech end (M1).

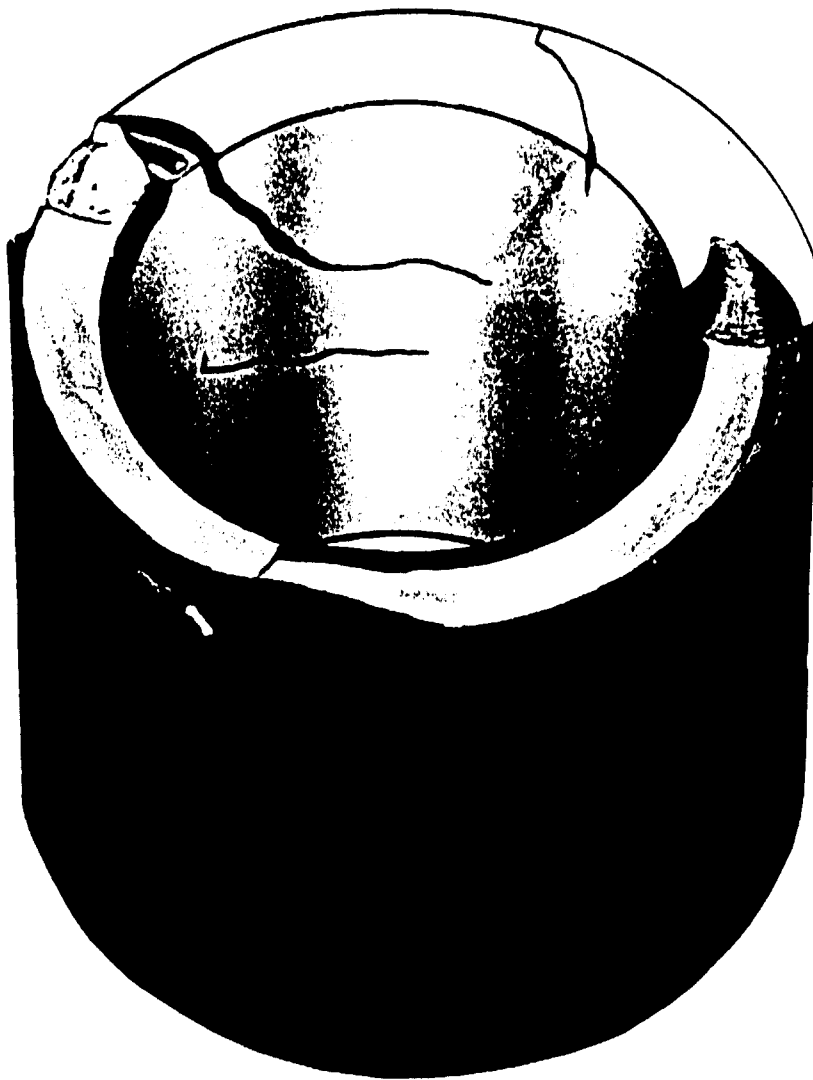
Figure 4. Segment of gun tube with fracture located near muzzle end (M2).

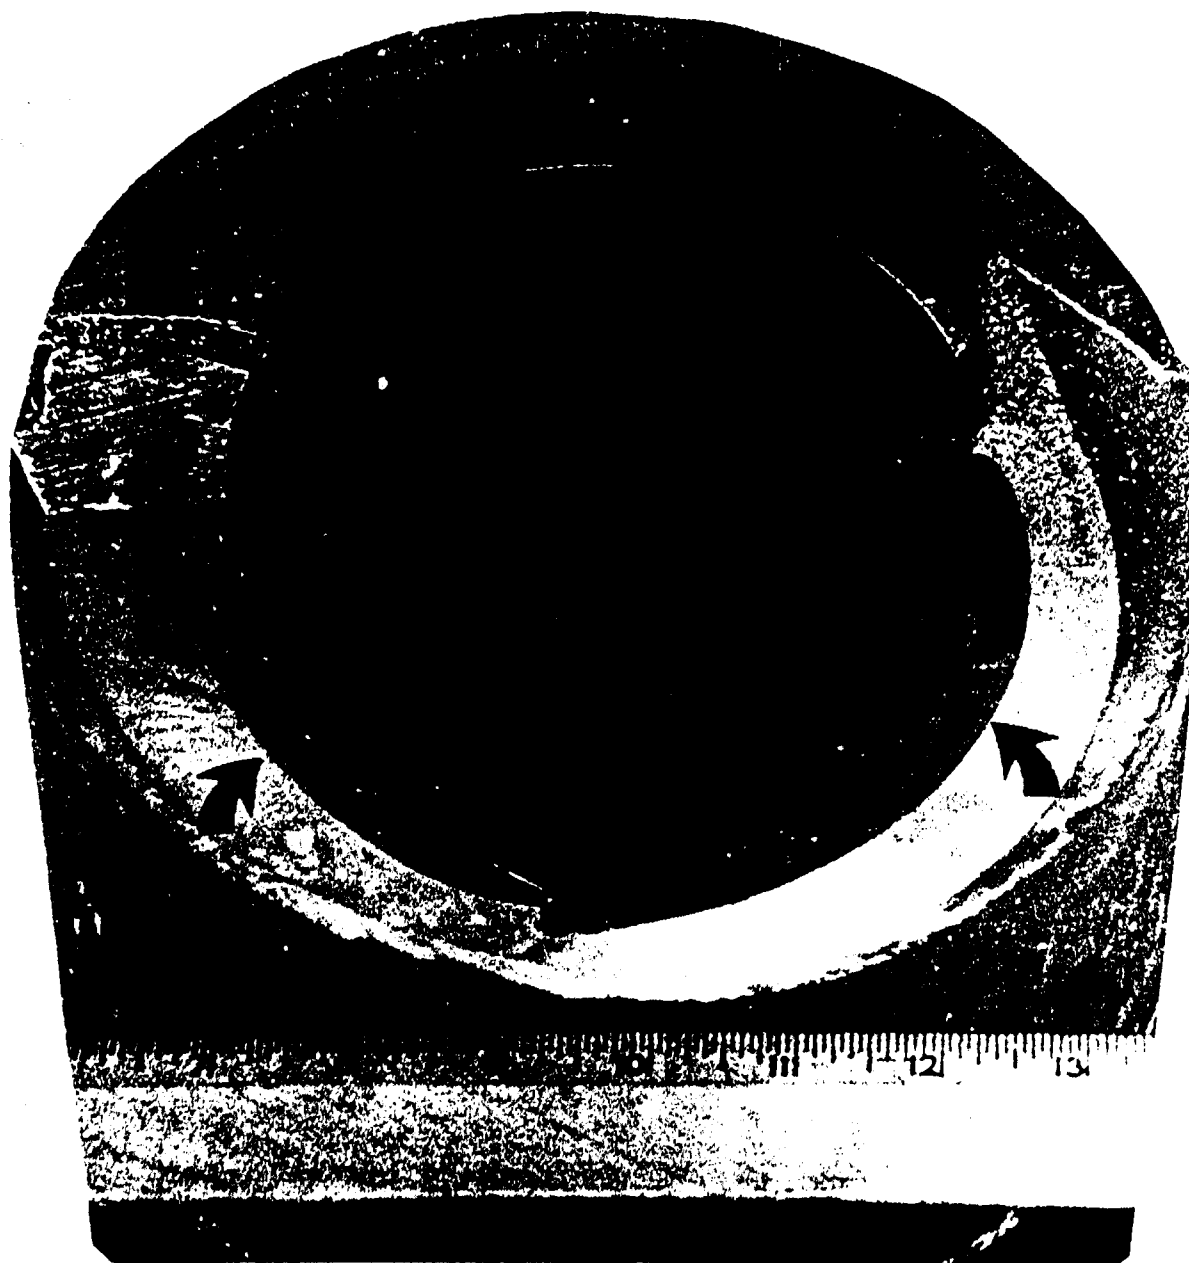
Examination of the fracture surface, seen in Figures 5 and 6, revealed a dark gray region extending from the bore surface into the tube wall. This region is relatively smooth and is a result of quench cracking during the hardening cycle of the heat treatment. The dark gray appearance is due to subsequent oxidation during tempering. The depth of this dark region is about $\frac{3}{8}$ inch. The circumferential crack (fracture surface) veered off into a longitudinal crack (Figure 7) with the same depth of oxidation, indicating it existed prior to heat treatment (tempering). Small cracks running skewed from the longitudinal axis were observed on the bore surface in this general vicinity.

Figure 5. Dark gray ring on half of the fracture surface (end closer to the breech) (indicated by arrows).

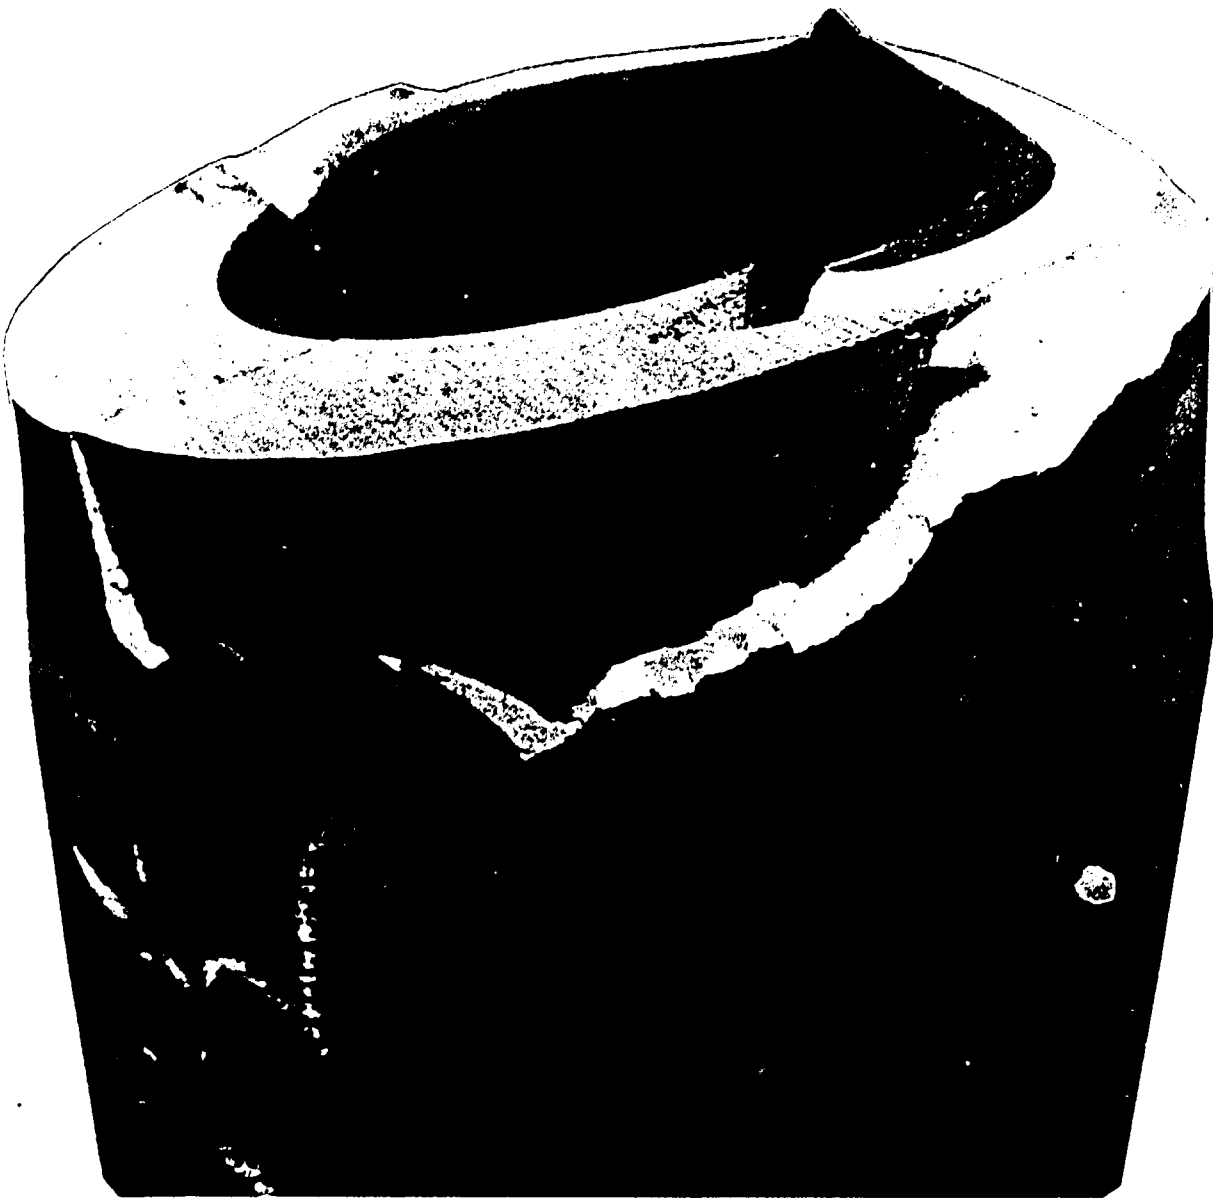
Figure 7. Side view of fracture surface showing secondary cracking (longitudinal direction).

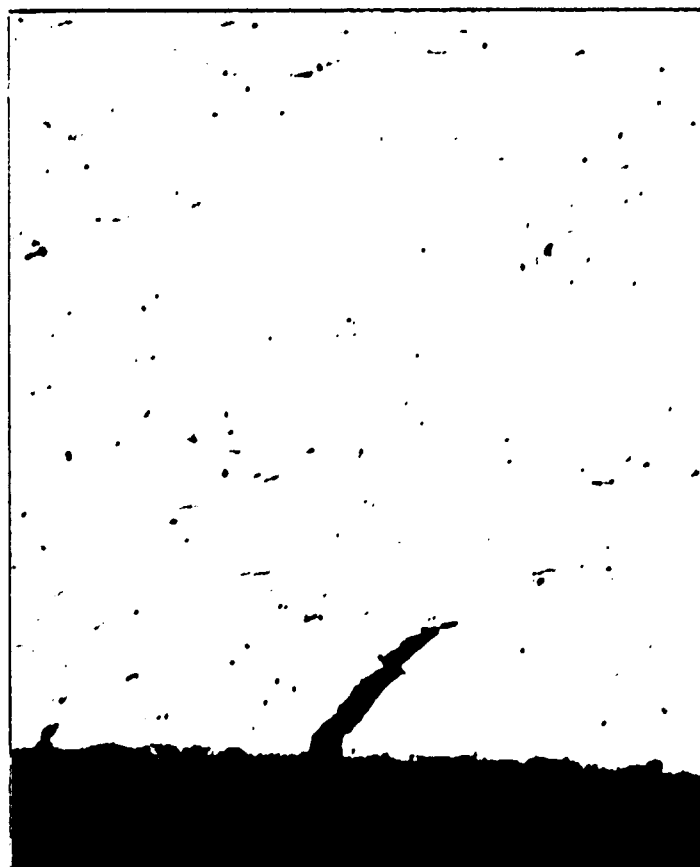
A circumferential crack on the bore surface was revealed under magnetic particle inspection conducted by Benet Laboratories. The crack, approximately 6.5 inches in length, and illustrated in Figure 8, was located about 6 inches from the fracture surface and 56 inches from the muzzle end. In addition, numerous smaller indications (approximately 1/8 to 1/2 inch) were observed, as shown in Figure 9. These indications appeared to have a helical pattern, suggesting they are associated with the forging flow lines, as shown in Figure 10. A representative indication was sectioned and measured approximately

3/8 inch long and approximately 1/4 inch deep into the cut face. Further examination of this defect was conducted during the metallographic portion of our failure analysis.

Figure 10. Forging defect in the same direction of flow lines (20X).

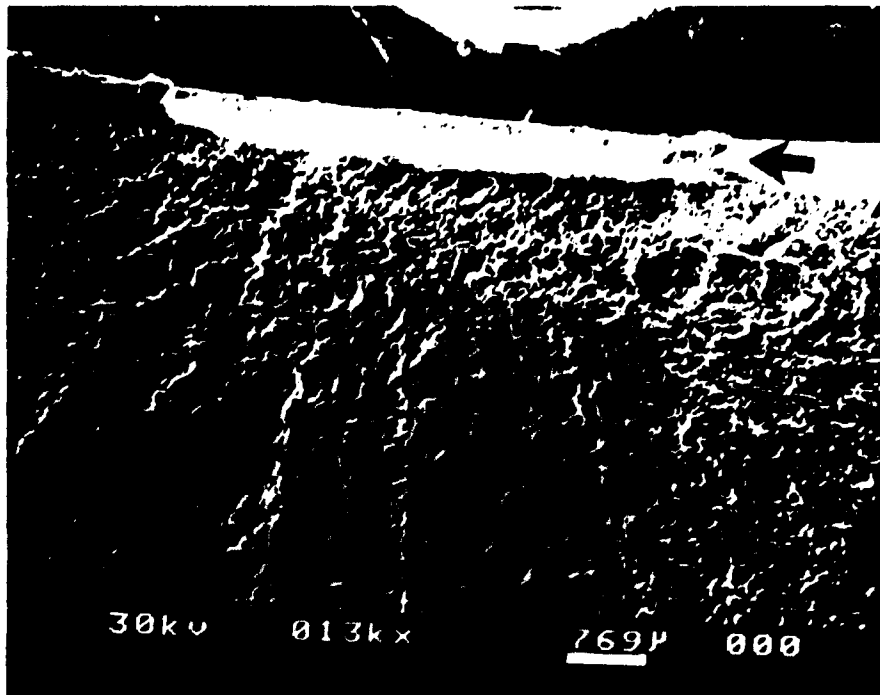
Examination by scanning electron microscopy (SEM) of a fracture initiation site, shown in Figure 11, revealed macroscopic crack indications propagating into the oxidized layer of the fracture surface. These indications were crack-type in nature and of substantial depth, as illustrated in Figures 12a and 12b. The orientation and flow pattern of these indications are identical to those observed during magnetic particle inspection.

Figure 11. SEM of fracture origin
(indicated by arrows).

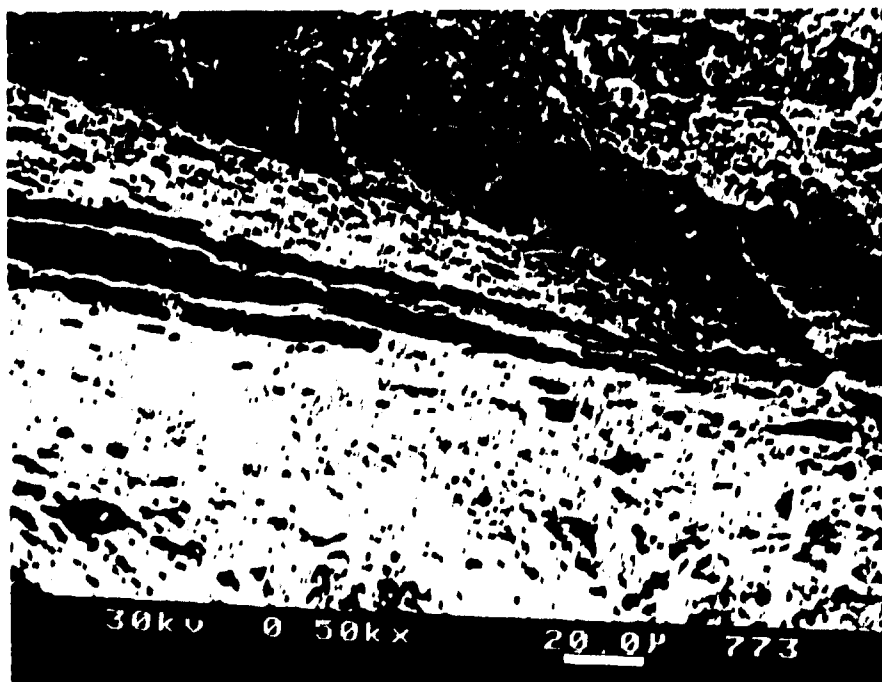
SEM was also conducted on the fracture surface of the tensile bars. The fracture surface disclosed nonmetallic inclusions determined to be manganese sulfides (MnS) by energy dispersive x-ray analysis (EDXA). Figure 13 illustrates the morphology and distribution on the fracture surface. The fracture mode was of a ductile mechanism.

Figure 13. EDXA illustrating MnS inclusion (500X).
